RIO RUIDOSO ASSESSMENT

JULY 30, 2010

by
Van Clothier
and **Steve Vrooman**

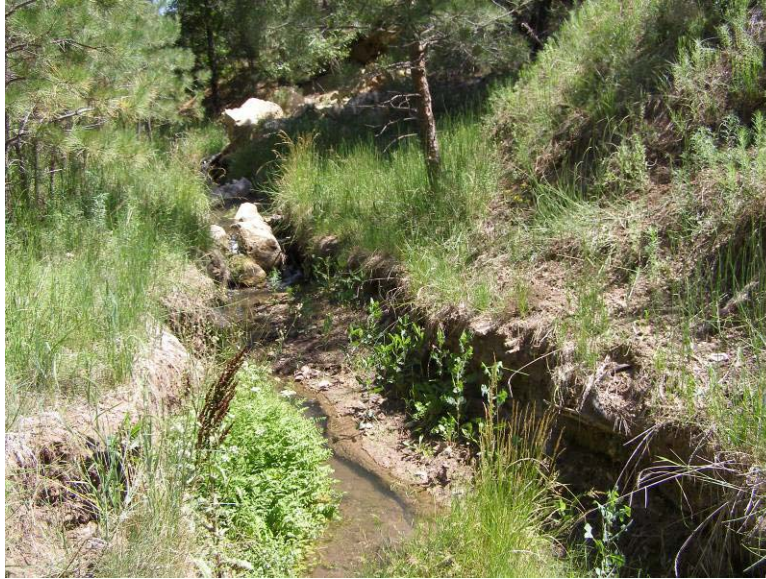
Gavilan Canyon Creek is entrenched for much of its length

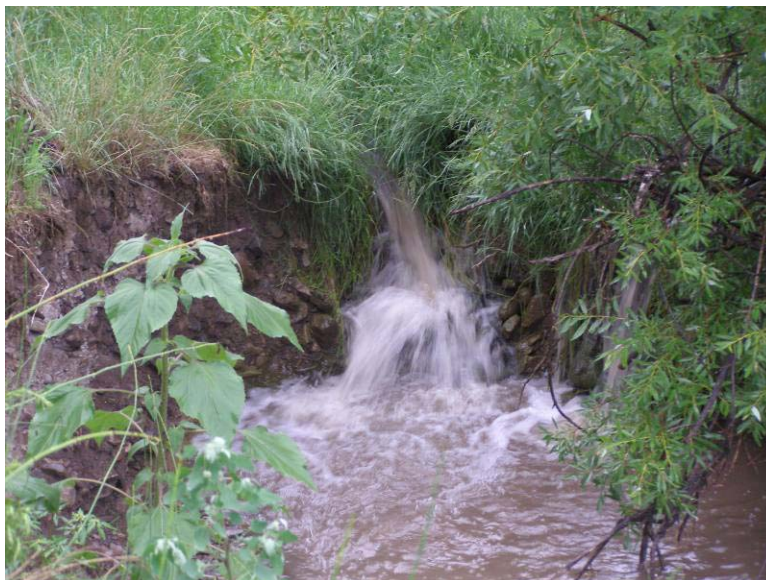
This headcut on Cedar Creek is an erosive dropoff that moves upstream, lowering the channel and the water table as it progresses.

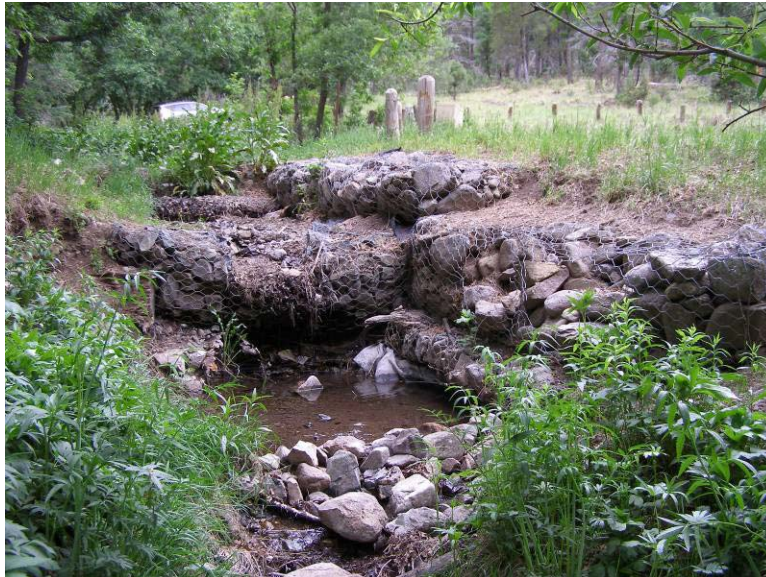
Undercut Gabion revetment on Eagle Creek

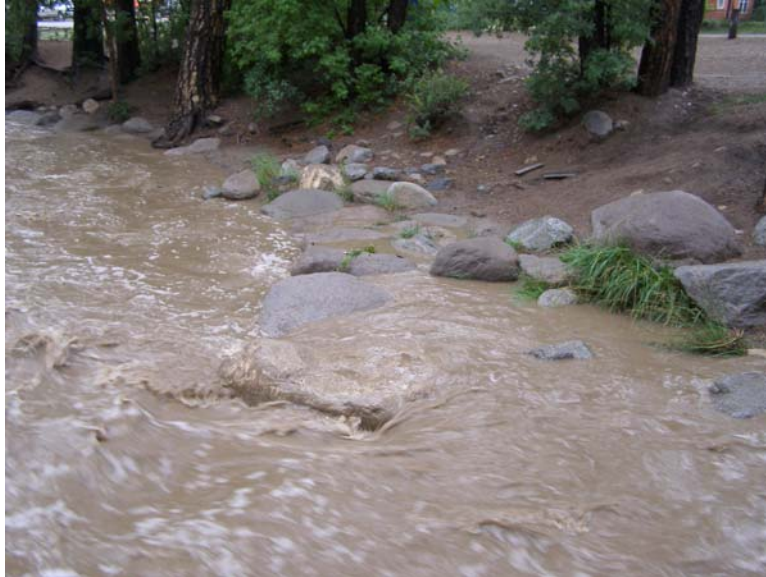
**Rock vane at Two Rivers Park
This protected the bank from erosion during the 2008 flood**

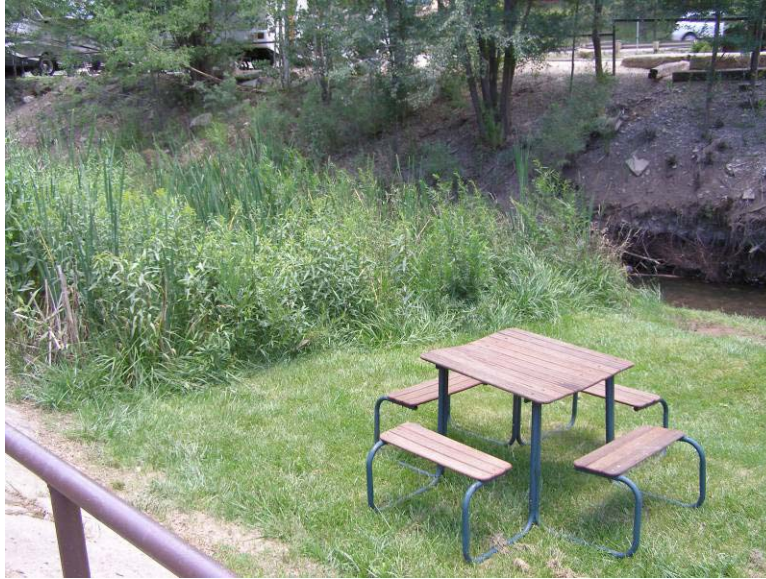
Mowed vs un-mowed floodplain near Rainbow RV park, a narrow buffer strip on the stream bank would improve fish habitat.

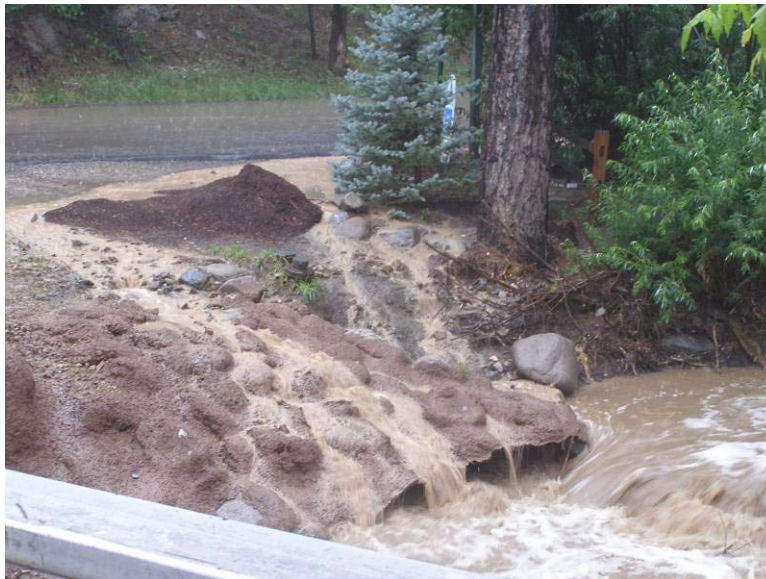
Urbanized runoff sending muddy sediment directly into the Rio Ruidoso

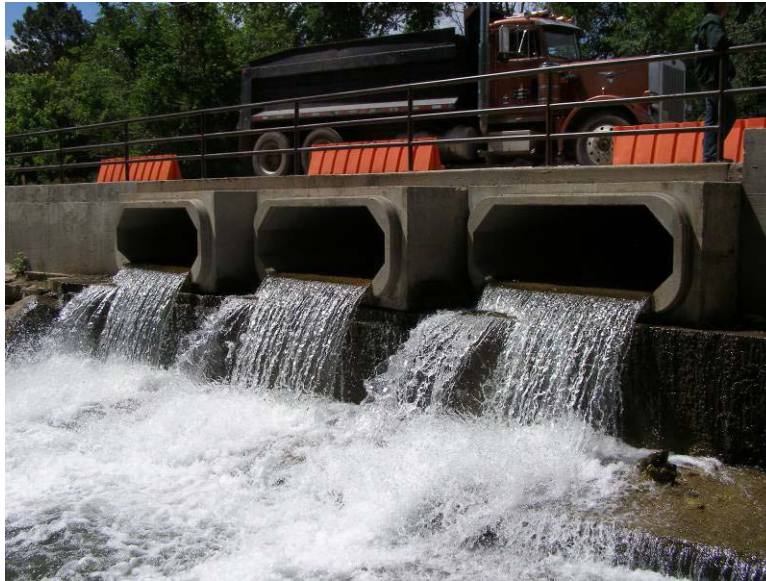
Gavilan Canyon Road bridge over Rio Ruidoso, showing fish barrier and scour pool

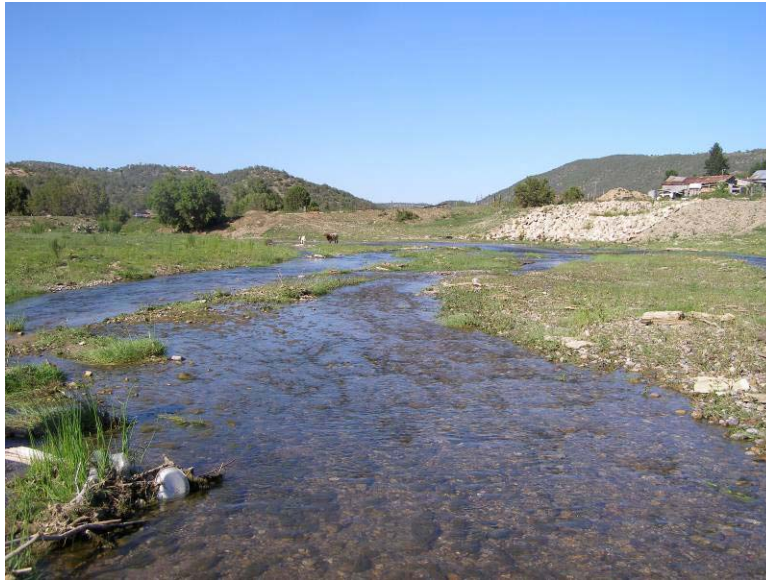
**Straightening the channel can cause it to be wide and shallow in some cases.
Note: improper livestock grazing is also contributing to the problem here**

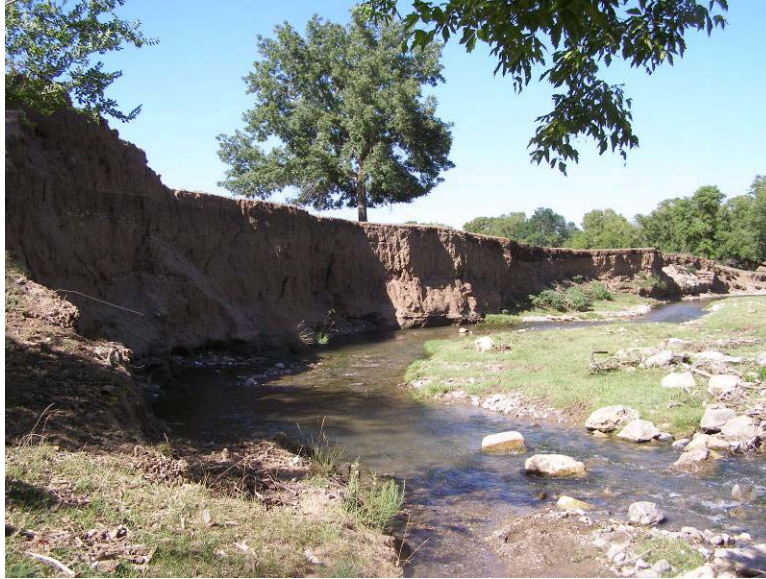
Photo taken from just below the irrigation diversion on the Stansell Ranch, looking downstream at bank erosion and scour

When a large irrigation diversion is installed on the Rio Ruidoso, several things happen. First, the river is most likely straightened to ensure that the water flows as desired. This causes a steeper slope in the vicinity of the straightening. Second, the grade control is usually placed higher than the original channel to raise the water high enough to flow in the irrigation ditch. This creates a waterfall effect downstream, which causes scour.

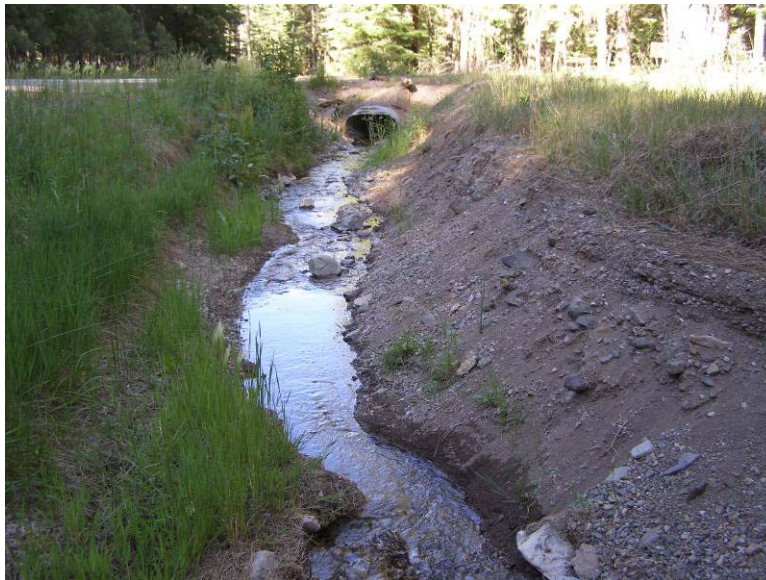
The major impact to Cedar Creek is the installation and positioning of culverts of private driveways in this reach. Many of these culverts were placed too low in the profile of the Creek, leading to headcutting of the bed of the Creek upstream. Downstream from many culverts, the acceleration of the flow is causing large scour holes to cut into the bed, also lowering the channel elevation by many feet.

The general effect of the culverts on Cedar Creek is to turn the Creek into a gully, which has no floodplain, poor vegetation, and a lowering water table. Once the gullying process begins, high flows are captured in the channel and cannot spread across the former

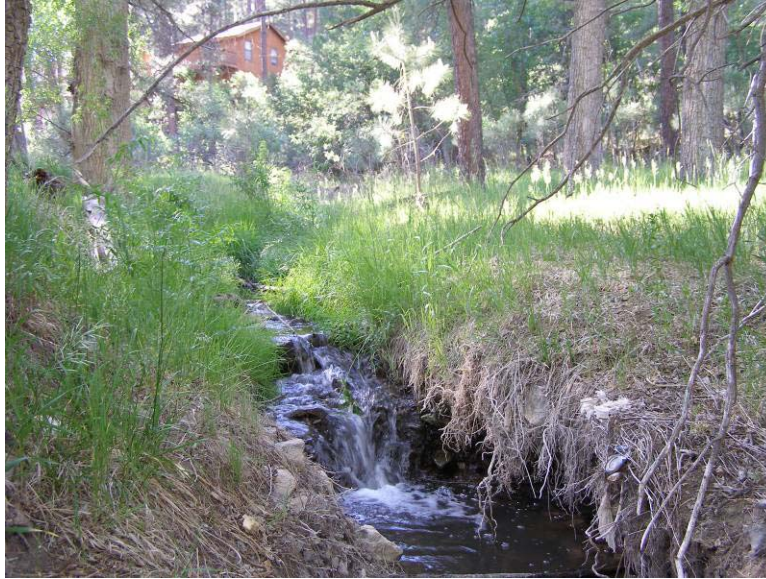
2. Irrigation ditches and entrenchment, headcutting

This portion of Cedar Creek was used for irrigation and the old irrigation gate can be found on the creek near to the trash compactor. It is very common in New Mexico to find that a creek was pushed from the middle of a valley to one side to allow more room for growing crops. The common result of this is entrenchment; long ago gullyng that has cut down to bedrock. Cedar Creek has cut to bedrock in several areas in this reach and is still cutting in other areas. There are many active headcuts damaging healthy reaches with riparian vegetation and lowering the water table. The active headcuts should be properly treated to prevent gullyng upstream. Areas between the bedrock could be treated with Induced Meandering techniques to create more floodplain and channel length.

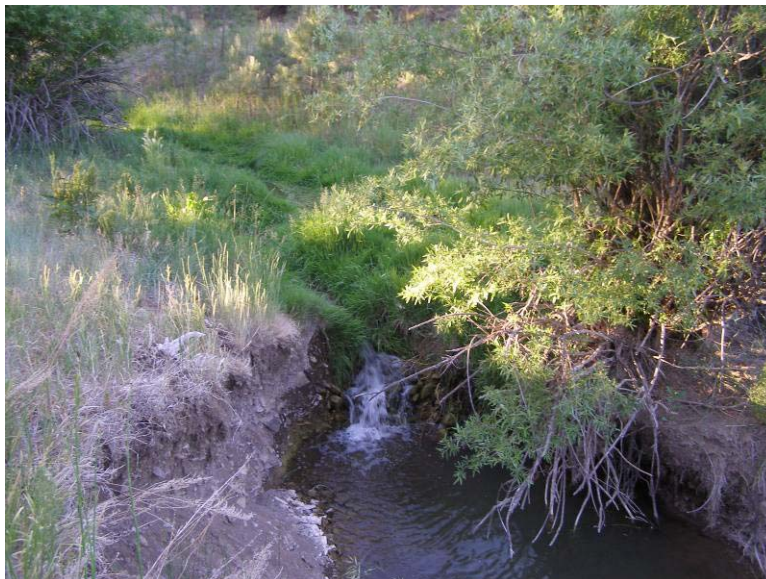
The box culverts at Mechem Drive were placed much lower than Cedar Creek upstream and caused a massive, four foot deep headcut. This headcut will advance upstream and destroy wetland and the healthy channel until it hits a bedrock area far upstream. A properly designed culvert inlet structure could stabilize this area and prevent resource damage on Cedar Creek upstream.

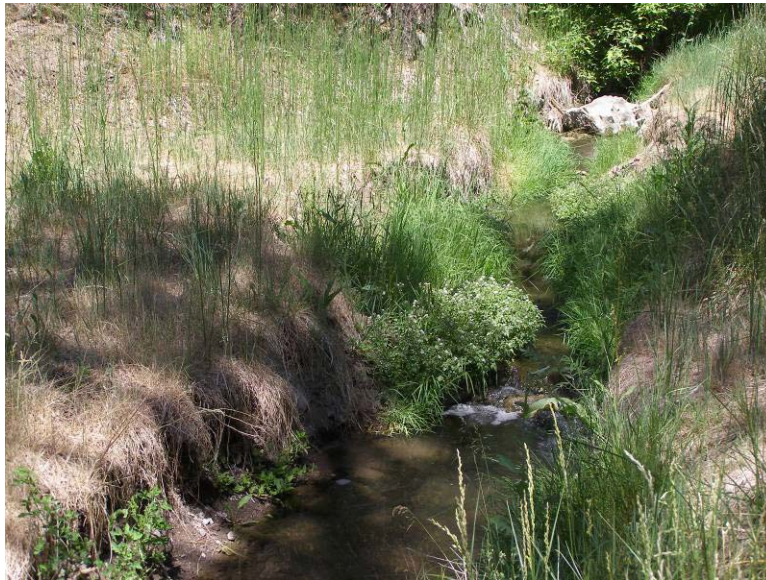
This reach is shady and forested and runs between private properties to Hull Road. Cedar Creek is relatively healthy, with riparian vegetation and small pools. However, this reach has cut to bedrock in many places and is not at its full potential. As more and more bedrock becomes exposed, the riparian vegetation dies and more of the creek becomes shallow and exposed. Small rock structures to hold water and grow vegetation could raise the water table and prevent further headcutting. This work could be done by hand in a workshop using volunteer labor and educating the community on watershed health.

Approaching Hull Road, much of the sediment that washed off of the bedrock upstream has been captured behind the under-sized culvert and has created a 1-2 acre wetland. A few small treatments by hand could re-wet another acre of this wetland and raise the water table. The clogged culvert should be cleaned out and drop inlet installed to raise and protect the grade of the creek.

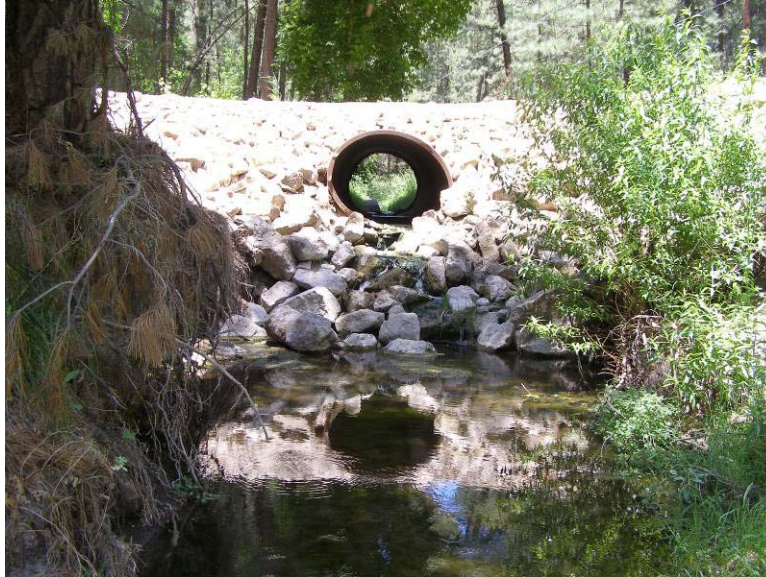
Several road and driveway crossings have culverts that were installed too low and have caused gullying and downcutting. The road crossing at Hart Bridge is particularly bad and creates a barrier to fish found downstream in Cedar Creek. Upstream, it is clogged with rock and threatens to wash out the road. This would have to be rebuilt to allow for passage of fish upstream to the rest of Cedar Creek.

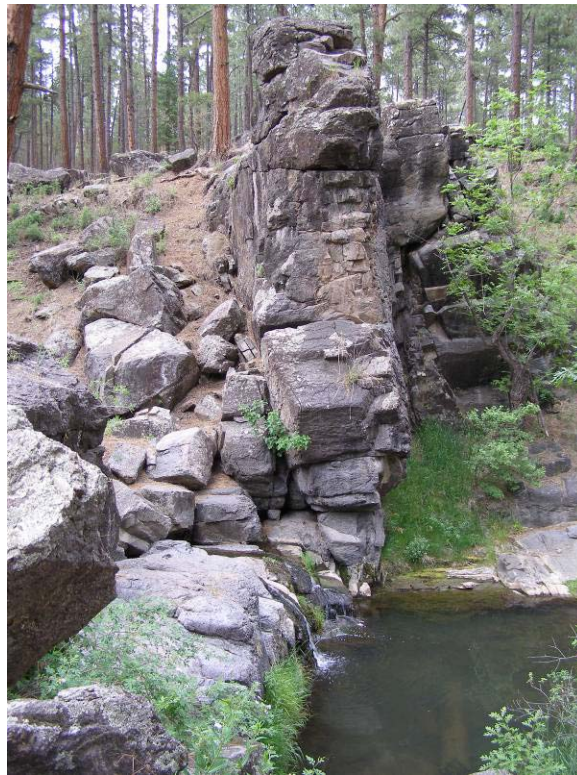
Access Road

Presently, access to the area is down the extremely steep access road used by the reservoir operators. This would be too steep for small children or the elderly. The road then crosses the creek several times, causing resource damage with small or improperly placed culverts. This road could be moved out of the floodplain onto the left (north) side of the creek to continue to give fire protection access.

The main resource damage in this reach is caused by the road crossings. Either the road could be moved, or treatments could be installed to prevent headcutting and gullyng from the poorly placed culverts.

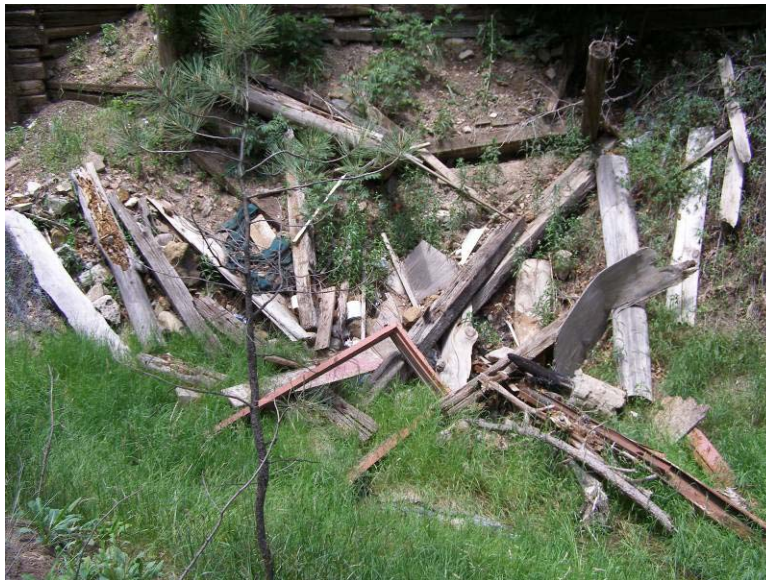
Several locations on Gavilan Canyon Creek have private property that encroaches on the creek. Private landowners have increased their flat, usable area into the creek by adding fill, garbage, and debris. Several locations are very trashy and are causing resource damage to the creek. Education and outreach to the landowners to encourage them to apply for permits before placing fill within the flood prone area of a creek to avoid possible prosecution and fines.

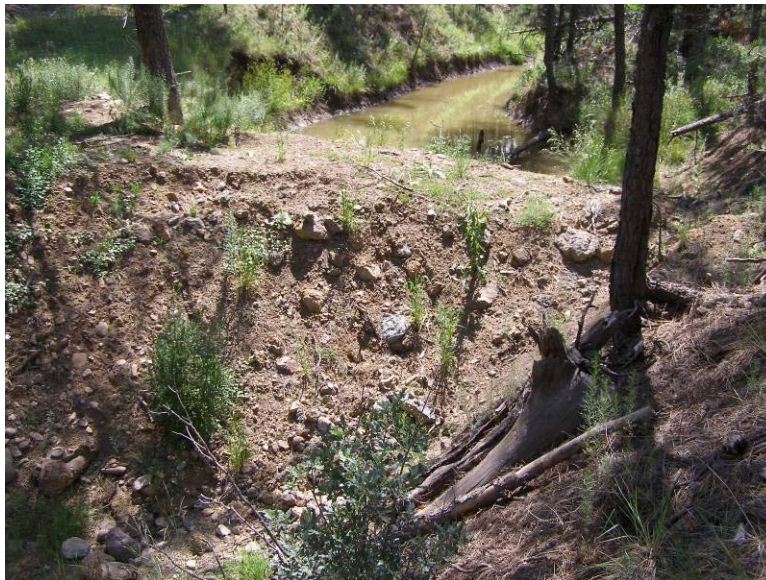
There are several illegal ponds dug into the creek in this dry portion of the creek. The areas we identified are dirt ponds with no rock armoring and poor compaction, most likely built by the landowner on a lark. Every pond appears as if it will break in the first large flood and would certainly not survive any overflow of the pond. Building ponds in watercourses without a permit is against federal law. When the ponds break, the water and material may wash downstream and cause damage to road crossings or downstream landowners.

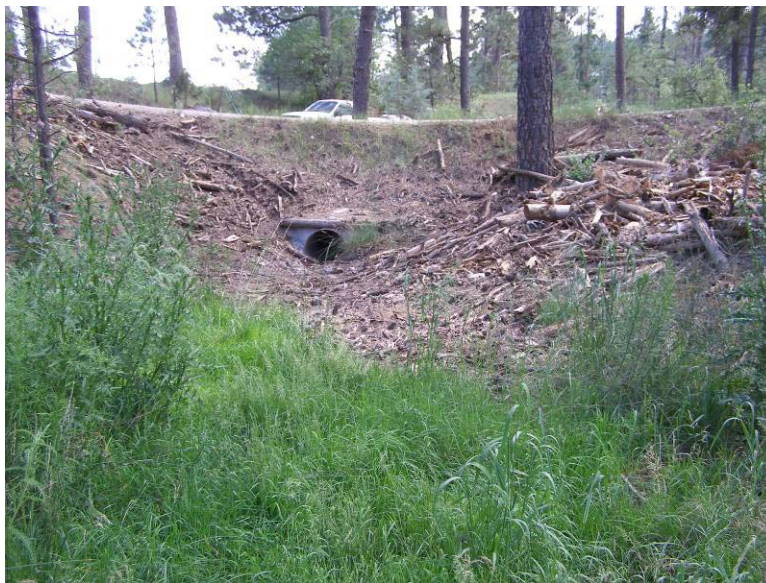
Downstream this far in the watershed, the size of a 2 to 5 year flood will be large. However, most of the culverts in this area use one 2 or 3 foot diameter culvert. The creek is entrenched deep in the landscape and the embankments around the culverts are very tall. No sediment is passed by the creek through these small culverts, which become ponds during a flood. Downstream, this lack of sediment is causing gullying and drying out of the Gavilan Canyon Creek.

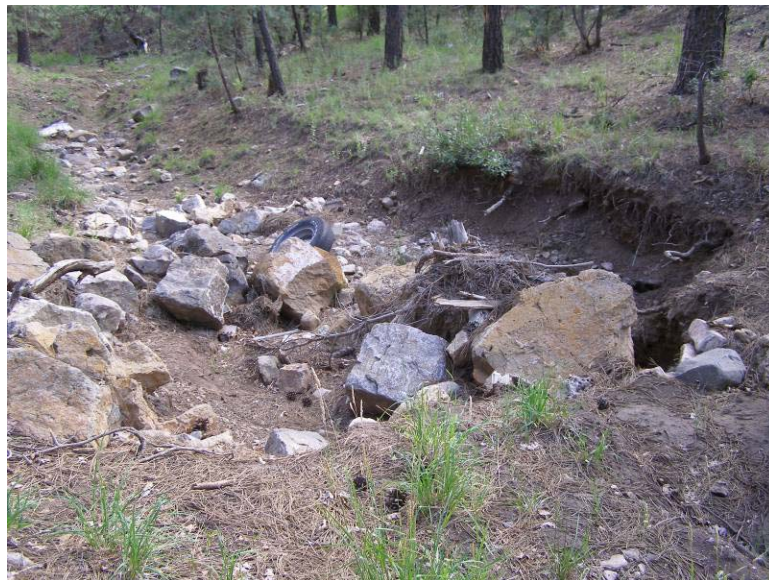
One old road crossing near the crossing at Gavilan Canyon Road has a 10 foot headcut that is eroding upstream. There is easy access nearby for an excavator to fix this resource damage with a rock drop structure.

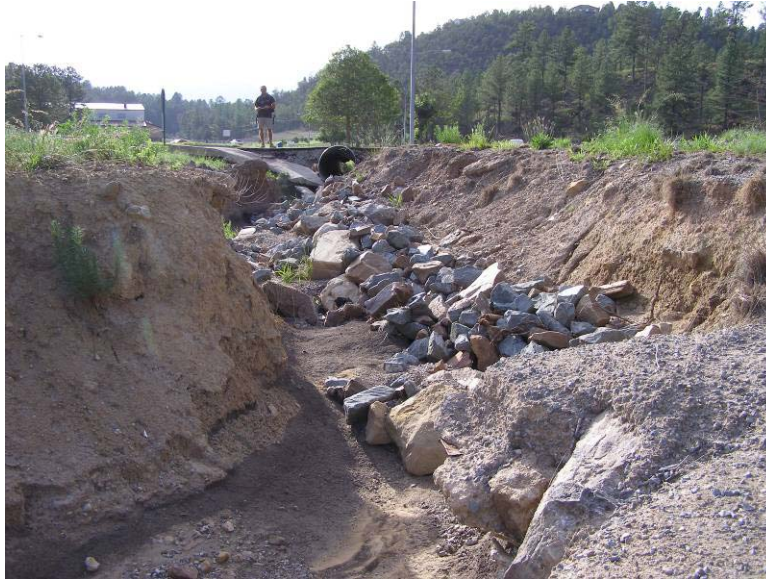
1. Draining of wetland

The upper portion of Bog Spring starts close to Hull Road. Very quickly, the spring area drains into a gully and flows in the roadside ditch on Warrior Road. Some potential exists in the long jump area of the track to create small wetland pond areas that would be amenities and grow shade trees and vegetation.

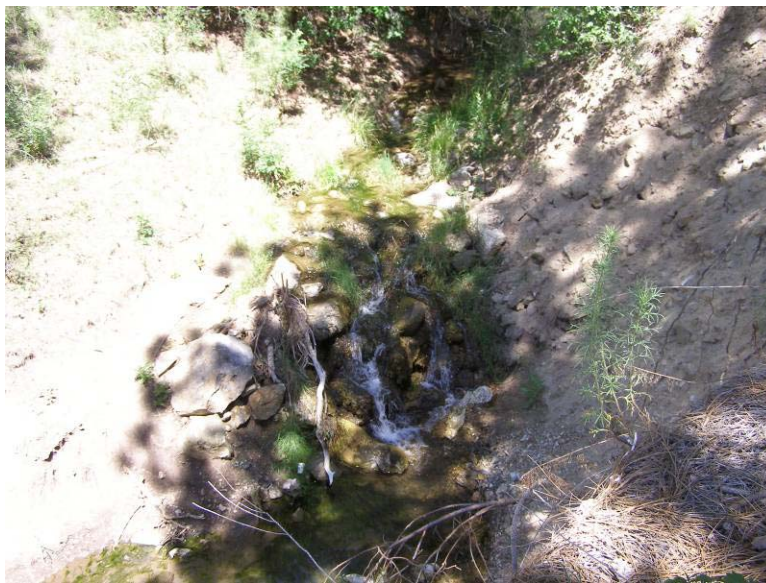
The bedrock areas the creek has cut into form many large and small waterfalls that have the potential to act as fish barriers if this reach were to be stocked. Two large waterfalls present 10 foot drops to the creek, and cause a large amount of erosion downstream due to the force of water over the drop. There is no 'solution' to the waterfalls, but they are fish barriers and are important to the health of the creek.

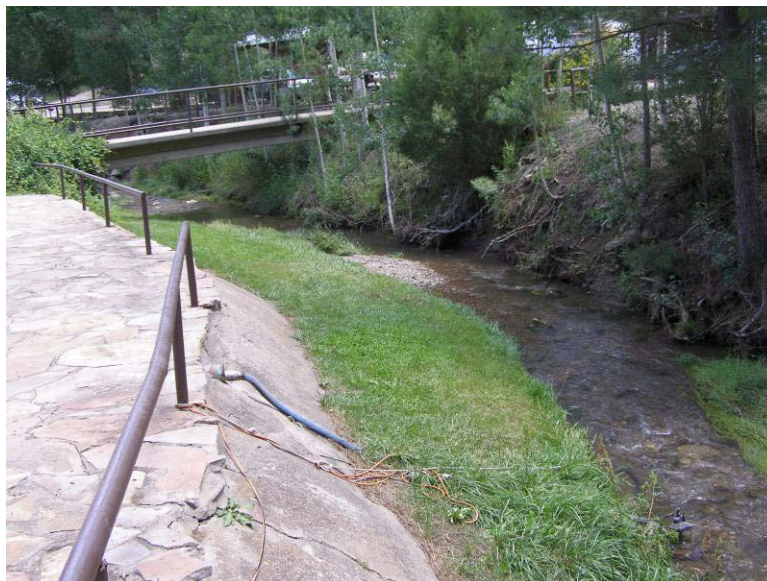
Many of the private properties have added fill to the floodplain to create flat ground for lawns or building pads. This has entrenched the creek and destroyed the floodplain along the creek. Dirt fill has also killed much of the bank vegetation and keeps the creek in full sunlight throughout this reach.

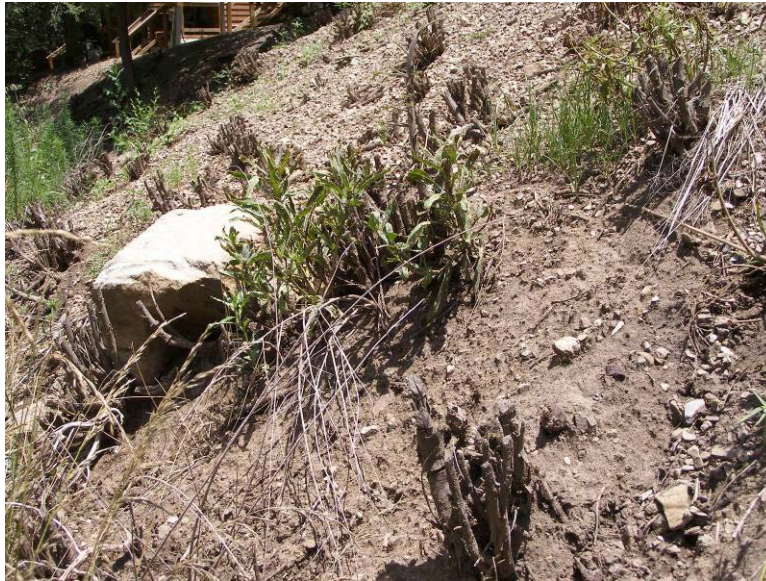
Many landowners along this reach mow or spray their floodplains with herbicide to kill the vegetation. Willows and riparian vegetation play a very important role in stream stability, flood attenuation and fish habitat. In several places, the floodplain is mowed to a lawn, which kills the riparian vegetation and does not provide the same quality habitat as native vegetation. There is even evidence of herbicide used on willows, which were holding a very tall fill bank from falling into the stream. Now the bank is unstable and the willows are dead.

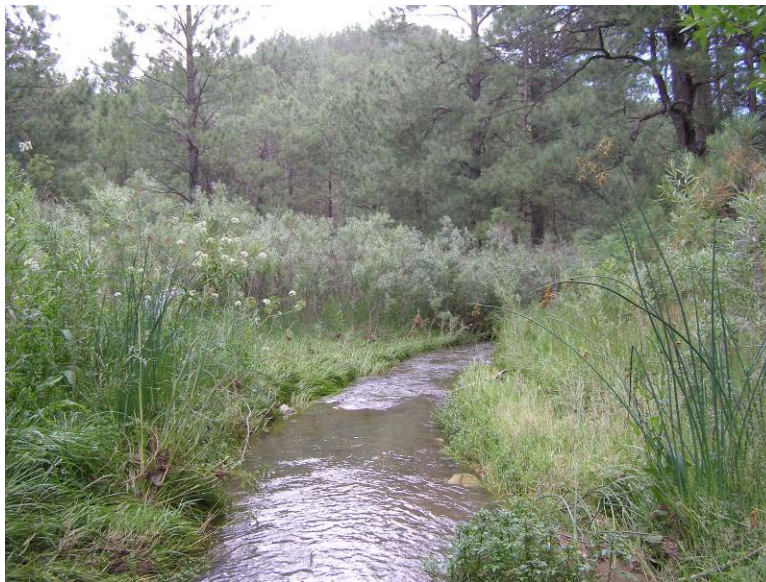
3. Great habitat and reference reach for Carrizo Creek

The portion of the creek from the confluence with Grindstone Canyon to Tomahawk Road is very healthy with a large floodplain, strong willow component and very deep pools. This is the best reach on Carrizo Creek and supports many fish.

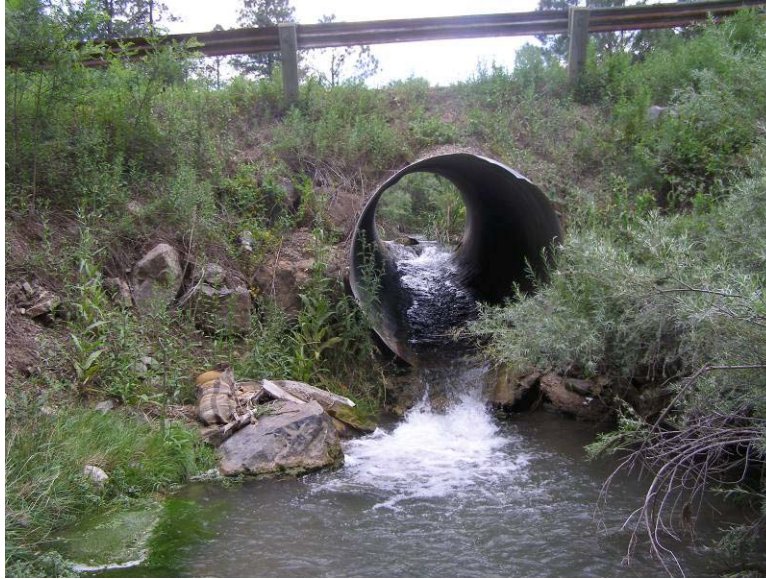
The culvert at Tomahawk Trail flows from an extremely healthy area with willows to a healthy private reach. Unfortunately, it is a barrier to fish on the downstream side and needs a splash pad grade control to lessen the drop out of the culverts.

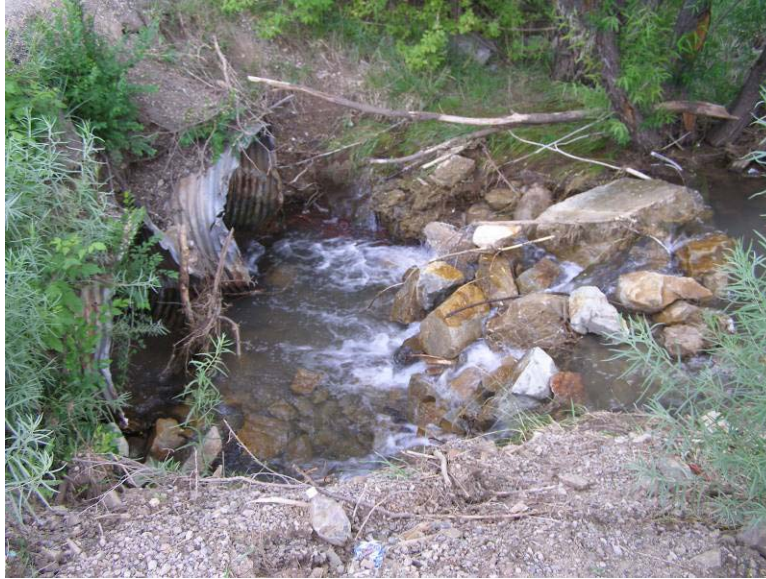
There is a major rock grade control on the Quarry upstream of the bridge. This is constructed of a number of rocks dumped in the creek and is a 2 foot drop that is a fish barrier. The quarry could run very well without affecting Carrizo Creek if there was no fill on the floodplain, however, the creek has been intentionally confined by fill, causing the need for this grade control. There is also hydraulic fluid flowing from a broken jackhammer/backhoe flowing into the creek.

This landowner may be contacted and even shown how to construct a better grade control. They obviously maintain this reach to hold the grade of the creek, and upstream of this grade control is a long pool with many fish. Barney Rue also has tons of hand-sized rock that could be used for hand-built restoration structures all over the Rio Ruidoso watershed.

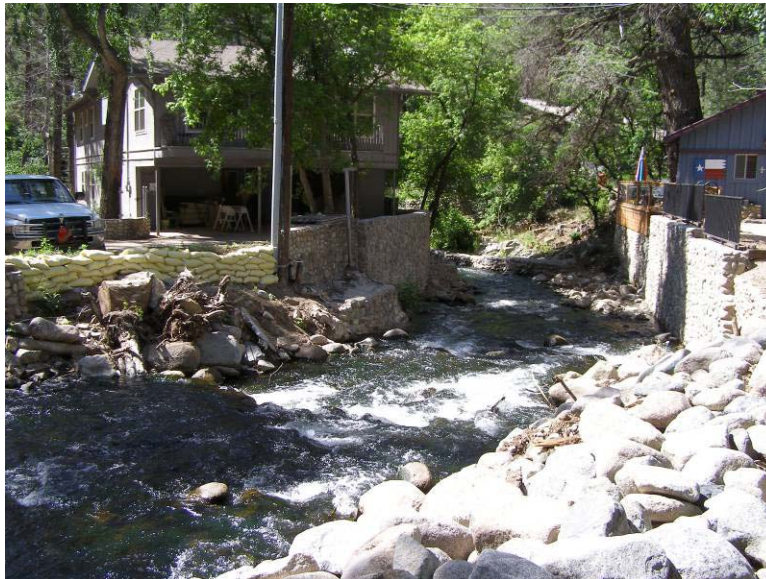
Encroachment on River

There has been a large amount of development in Ruidoso on the banks of the Rio Ruidoso. To keep the foundations of the house or building dry, the floodplain of the river has been filled in and lost to the river. This lack of a floodplain caused the flood event to be much higher by confining the flood. The presence of buildings or houses in the 100 year floodplain caused the water to spread even wider and flood buildings that would have been safe if the banks of the river had been left undeveloped.

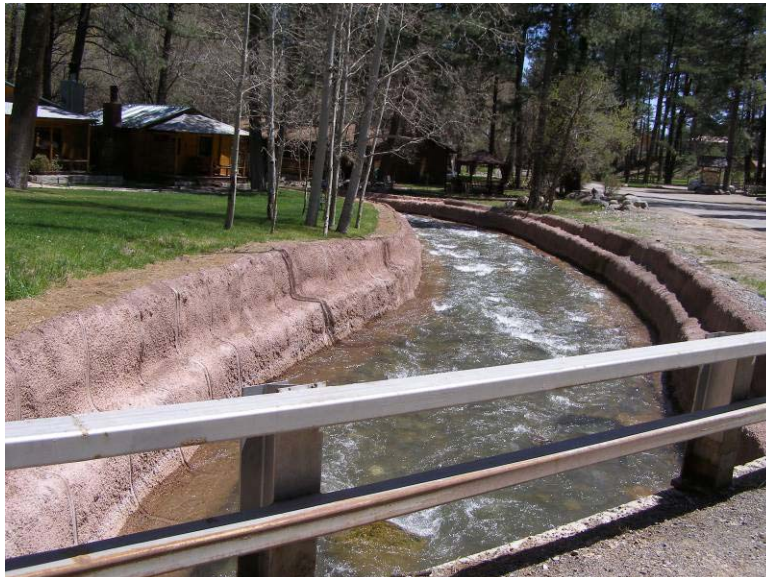
The gunnite bank protection placed after the flood was an attempt to protect properties from the next flood. However, this 20,000 linear feet of bank protection has changed the Rio Ruidoso forever in unfortunate ways.

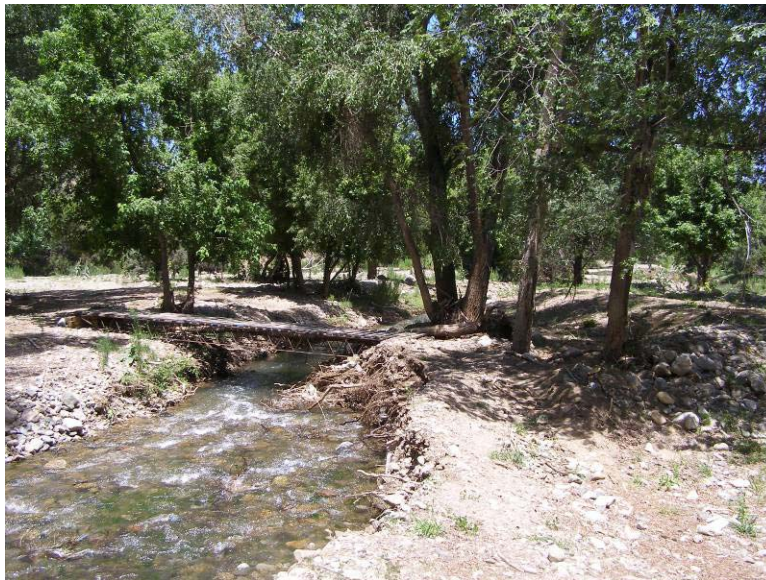
This area is still being used as a ranch (as well as a Frisbee golf course) and there is heavy grazing of the banks and the river. This prevents the growth of willows and riparian vegetation on the banks that would narrow the river, create meandering, and provide excellent fish habitat. If portions of the river channel were fenced from grazing, this area would rebound quickly and heal itself. The areas of the banks that are heavily grazed have no vegetation, as the damage from the 2008 flood with heavy grazing has prevented any grass from re-colonizing. Therefore there is little forage on these banks and small loss to the rancher if Cattle could be given access in particular areas between the fencing (road crossings) for water.

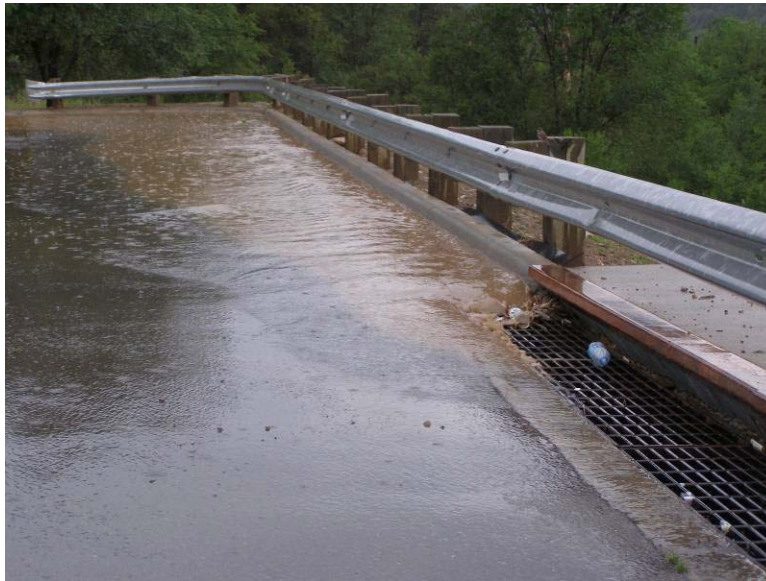
The majority of the run-off from Walmart cascades down the bank and flows unimpeded into the Rio Ruidoso. A small gabion has been installed to ensure that this runoff does not flow into the ponds (old channel) on the floodplain and be treated by natural processes. This site is an excellent location for a demonstration project treating stormwater runoff from Walmart.

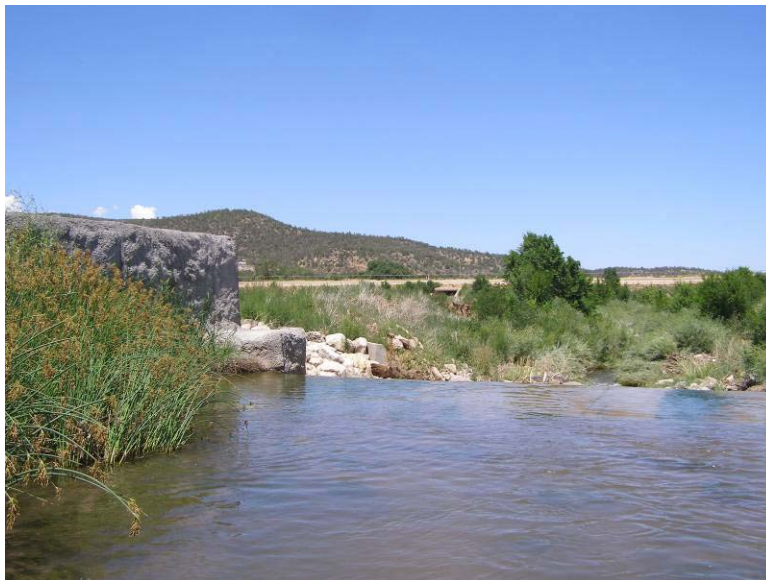
The grade control that was installed to hold the elevation of the river during the re-alignment has created a large fish barrier. A complete removal and re-design would be necessary to allow fish passage upstream. However, two very healthy reaches upstream and downstream would be connected biologically.

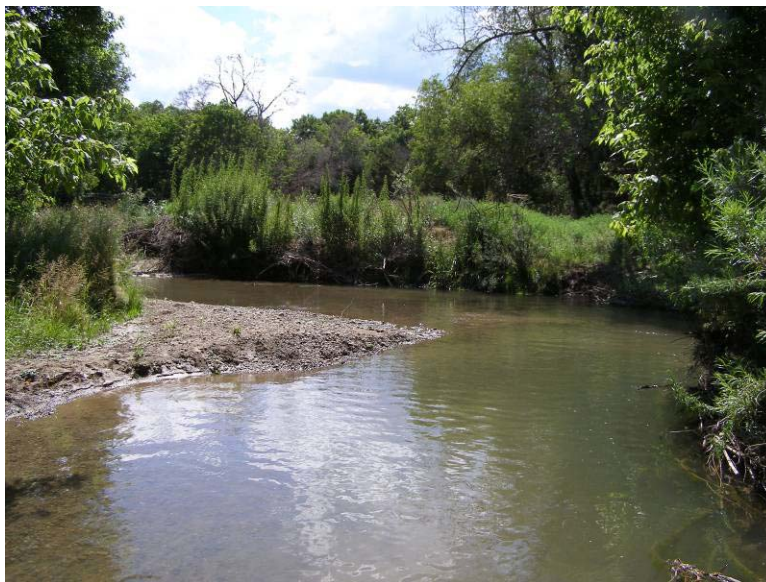
Reach 7: Private land above irrigation diversion (name of Beavers)

The healthiest reach so far was found on private property below All American Park. The river is not entrenched and has very healthy meandering and deep pools. The river in this area has the elevation stabilized by a large irrigation dam downstream. This reach is a reference for healthy river function near Avalon Road. One resource impairment was found in this reach.

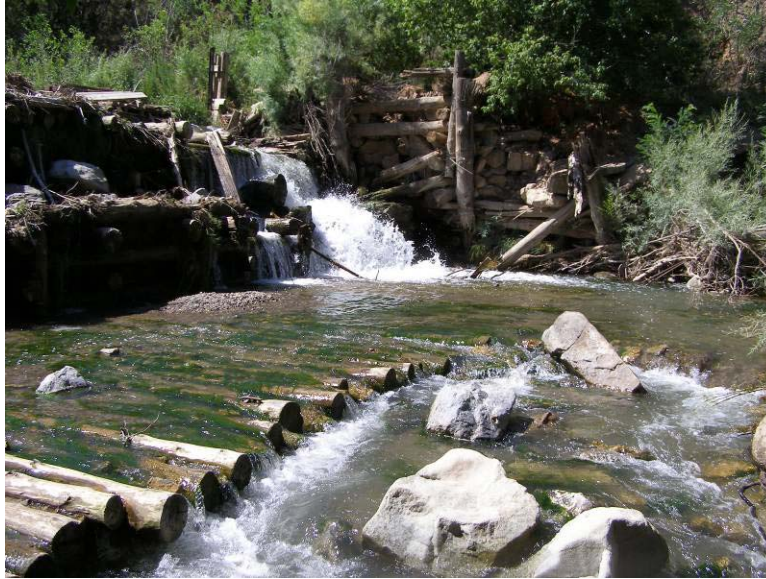
The healthy reach above drops to an entrenched gully after a large log crib dam irrigation diversion. This dam is probably historic, and is a huge, nearly impossible to fix barrier to fish migration upstream. The river downstream has little floodplain, is relatively unhealthy (few pools), and has many private properties on both banks that would prevent significant restoration. Two major resource impairments were found in this reach.

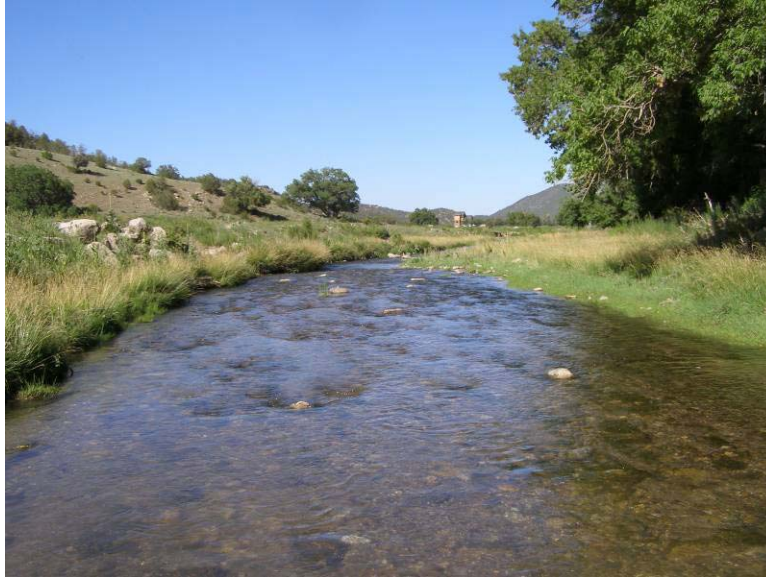
Reach 10: Circle E, Beall Family Partnership

The reach below the Stansell Ranch is managed very differently with horses and Llamas, neither of which eat willows or riparian bank vegetation. Due to this, the Rio Ruidoso in this reach is extremely healthy and provides a reference reach for the Stansell Ranch upstream. The river was able to adjust to the 2008 flood without significant resource damage. There is a beautiful duck pond on the south bank that is excellent habitat and a wildlife resource. One resource issue was identified in the assessment.

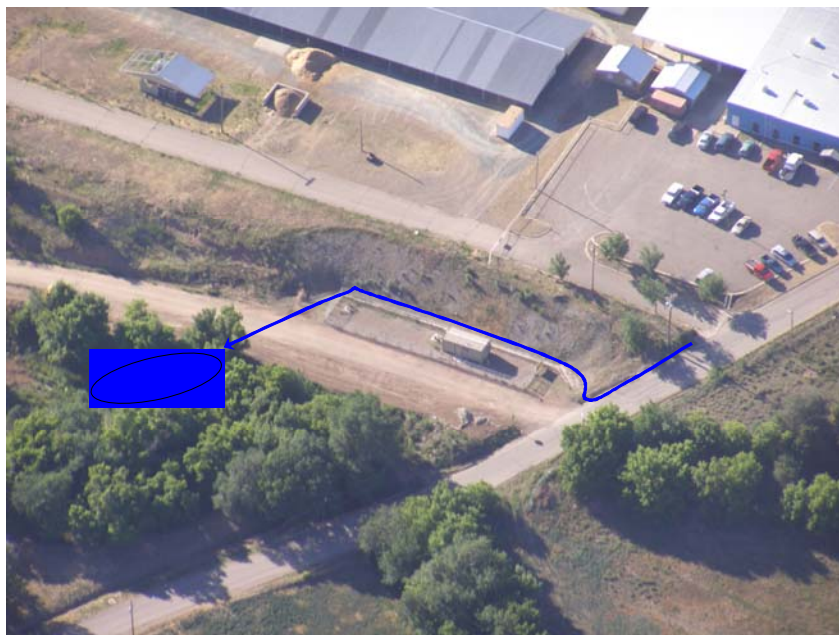
East side of Riverside Park

This newly built park is in the City of Ruidoso Downs. Two modifications are suggested to the design and construction of the park that would positively affect river function and health. On the east side of the park, a large gully brings stormwater past the park directly into the river. This gully could be treated with a rock-lined channel and the water harvested and spread across the park with small basins and water spreading structures. The second modification would harvest the water on the west side of the park and direct this water into the pond, as shown in the picture.
